# CONTRACTOR SAFETY ALERT

## Travelling with a raised boom

Number: 55

Issued: 10/01/2022

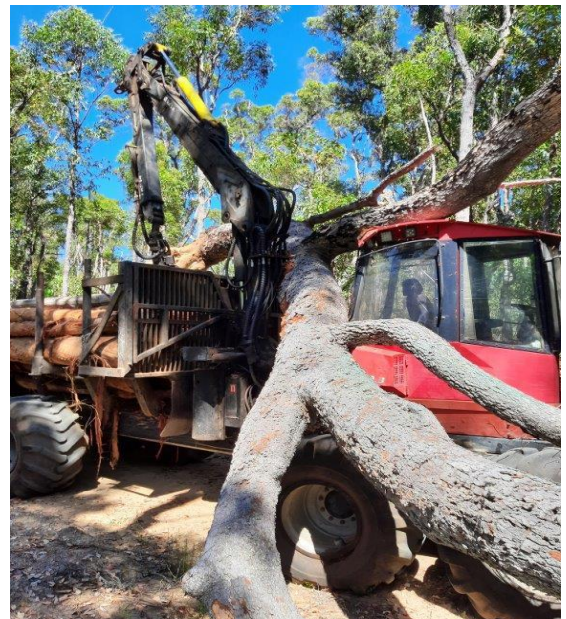
On Thursday 6th January 2022, an FPC contractor's forwarder has been commuting between cells, with its boom in a raised upright position.

The boom has struck the overhanging limb of a standing marri, which at its base, was rotten. The tree, as it fell has slid down the boom arm and become lodged in-between the cab and log bunker.

Fortunately, there were no injuries.

- The operator was travelling with the machines boom raised, whereas it should have been in a horizontal position.
- The operator was aware of the overhang and has misjudged its height in relation to the boom.
- The tree had been marked for retention as a habitat tree.
- It is unknown if at the time of tree marking the tree was identifiable as a potential hazard, but ongoing, if there are concerns of overhanging trees on access roads these should be reported.
- Highlights the importance of appropriate, compliant, and maintained machine guarding which should never be taken for granted.
- Contractors should refer to the "Forest Equipment Guarding Best Practice Guidelines 2020" for appropriate guarding standards for machines and associated activities, refer link below:
