CONTRACTOR SAFETY ALERT

5 stud spider hub failure

Number: 64

Issued: 13/05/2022

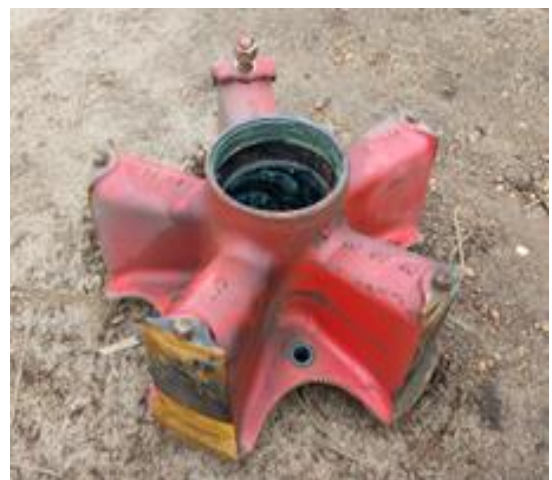
On 12th April, loaded FPC contractor log truck lost two wheels on its tri-axle trailer on the Southwest highway when all but one wheel stud sheared off the spider hub.

- An industry expert inspected the spider hub and has advised that one stud on the spider axle appears brittle and has most likely snapped off causing the remaining studs to fail, resulting in two wheels dislodging from the left hand, middle axle. The spider hub stayed attached to the axle, the axle did not drop.

- Speed, maintenance, and heavy braking ruled out as contributing factors.
- The FPC contractor has directed that a line is marked across the wheel nut, wedge and rim on one nut of each axle on all haulage vehicles with these arrangements. This will assist drivers to monitor movement.

- Industry consultation showed a consistent methodology for tyre fitting, maintenance and driving prestart and inspection. However, industry should also consider other initiatives to reduce the risk, this incident will be raised at the next Forest Industry and Safety Training Committee meeting for discussion.
